Waikiki Beach, Oahu, Hawaii: History of its transformation from a natural to an urban shore

Robert L. Wiegel

ABSTRACT

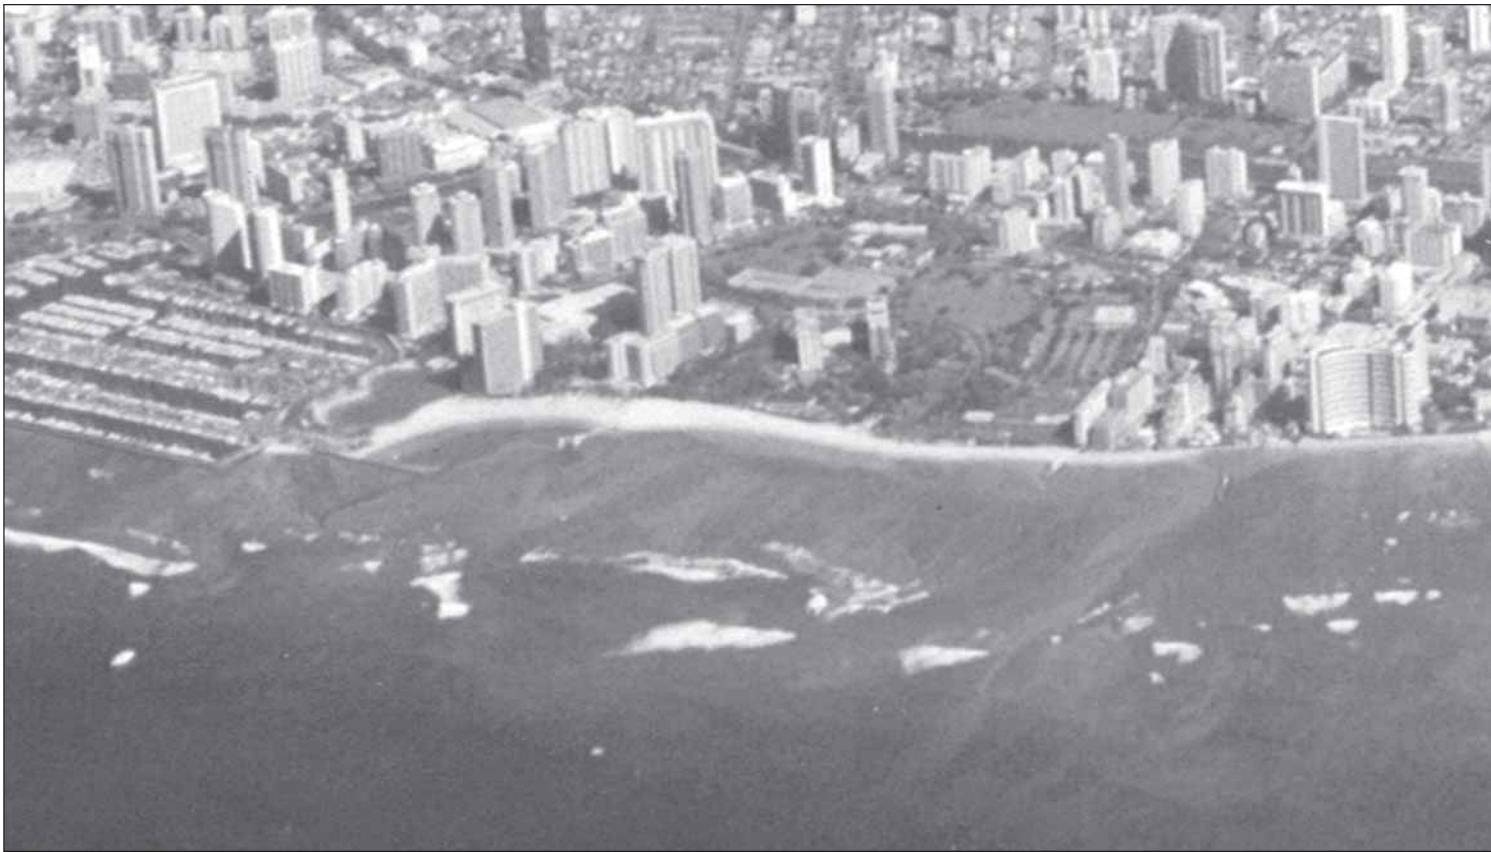
Figure 1. Waikiki Beach,, Oahu, Hawaii. Aerial photo, 24 January 1998; between Ala Wai Yacht Harbor (left) and Sans Souci (Kaimana) Beach (right). (By R.L. Wiegel, #8878.)

Figure 1 is a 1998 aerial photo of most of the extended Waikiki Beach. The section between Ala Wai Yacht Harbor is on the left, and Sans Souci (Kaimana) Beach is on the right. Figure 5 is a photo look-

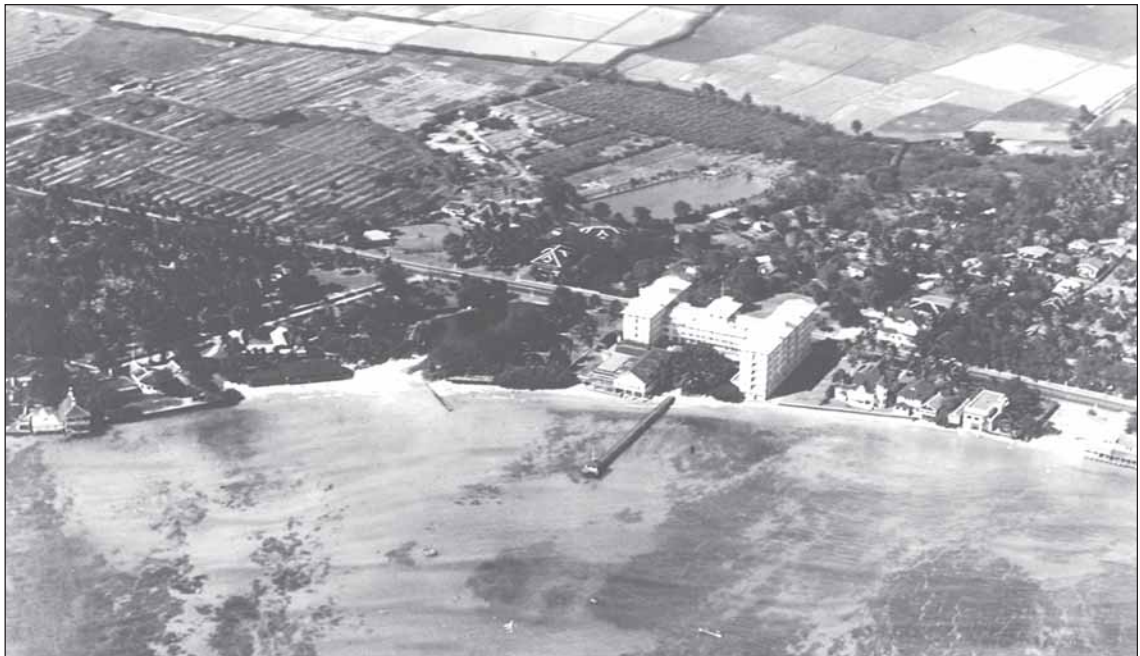
Figure 2.
Waikiki, Oahu,
Hawaii. Aerial
photo, 9
September 1920,
looking
landward over
shore; taro
patches, rice
paddies.
Apuakehau
Stream mouth
(almost closed
by beach sand),
Moana Hotel
and pier in
center. (U.S.
Army Museum
of Hawaii,
USAMH No.
1716.)

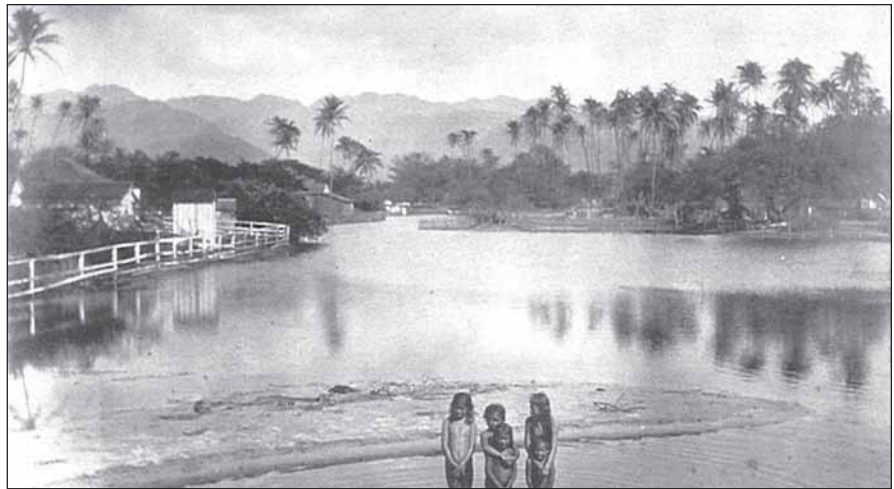
Figure 3a (above). Ku’eakaunahi Stream, looking inland from mouth, 1886. (A. Mitchell, Bishop Museum, Neg. No. CP 56428.)

Figure 3b (below). Historic postcard, circa 1912, Apuakehau Stream to left of Moana Hotel and pier; note stream mouth closed. (Island Curio Co., Jas. Steiner, Honolulu.)

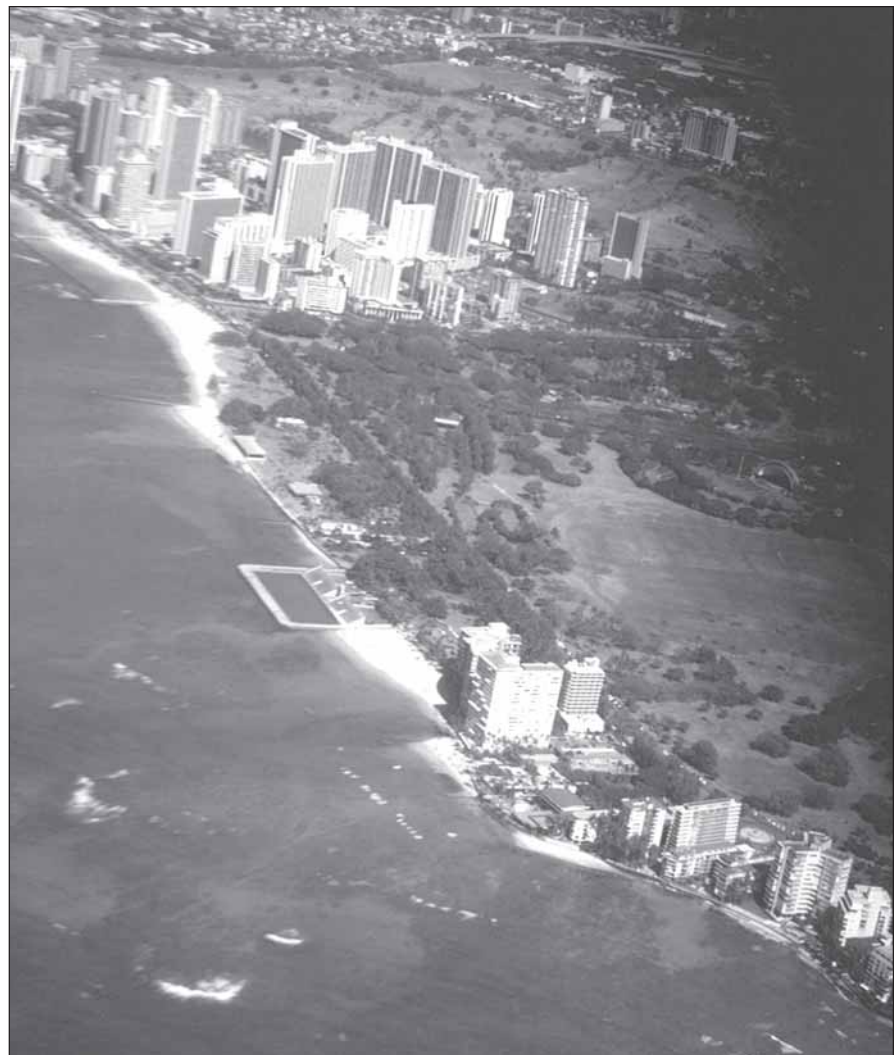
Figure 6. Waikiki Beach; aerial photo from offshore Diamond Head, 16 January 1986: Elks Club and Outrigger Canoe Club (at bottom of photo), Sans Souci (Kaimana) Beach, Natatorium, Kapiolani Park, Queen’s Surf Beach, and Kuhio Beach (top). (By R.L. Wiegel, #5581.)

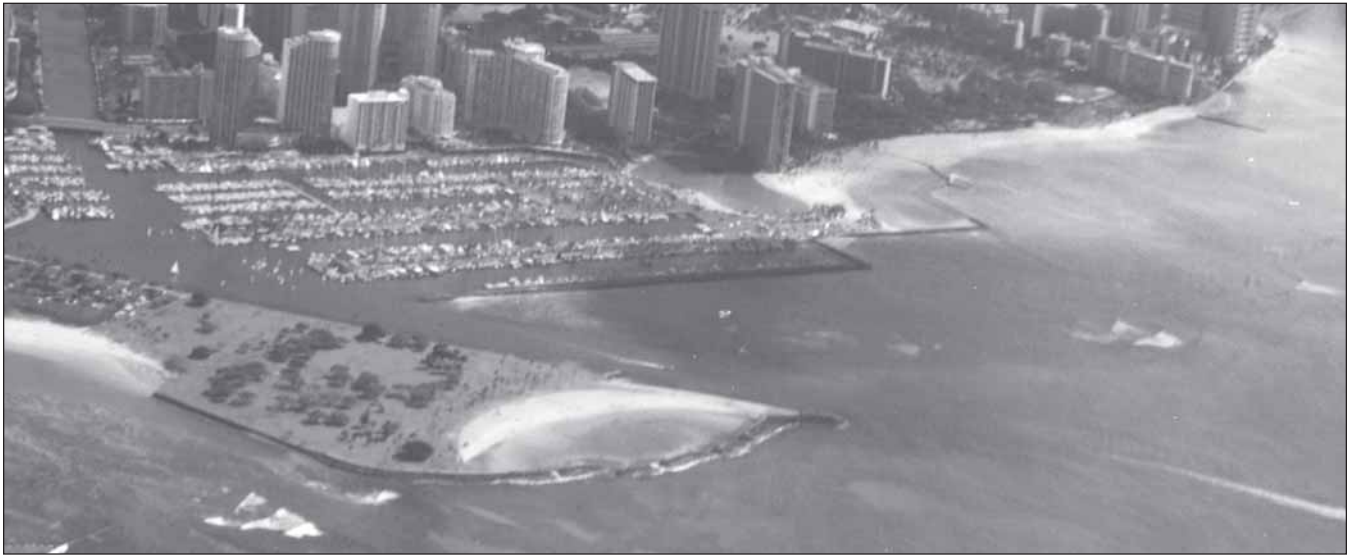
Figure 7. Magic Island (Aina Moana), Ala Wai Canal entrance channel, Ala Wai Yacht Harbor, Duke Kahanamoku Beach and Lagoon, Fort DeRussy Beach. Aerial photo, 30 January 1999. (By R.L. Wiegel, #9523.)

Figure 7 is an aerial photo from 1999 of Magic Island (Aina Moana) at the left, Ala Wai Canal entrance channel and Ala Wai Yacht Harbor at left center, Duke Kahanamoku Beach and Lagoon and Fort DeRussy Beach at top right and center right. Figure 8 is an aerial photo from 1998 of Kewalo Basin at the left side, Ala Moana Beach Park and dredged channel in front of the beach at the center, and the west side of Magic Island (Aina Moana) at the top right.

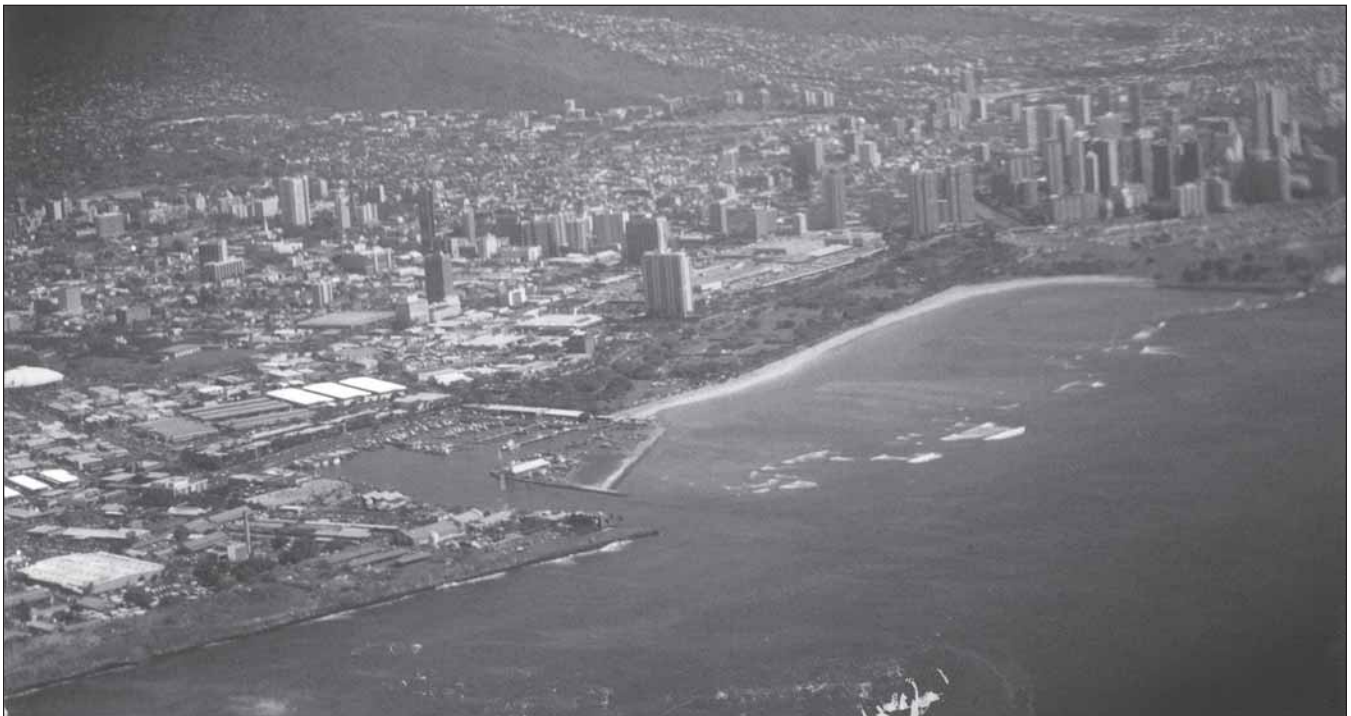
Figure 8. Kewalo Basin, Ala Moana Beach Park, Magic Island (Aina Moana); aerial photo, 19 January 1988. Note dredged channel in front of the man-made beach. (By R.L. Wiegel, #6354.)

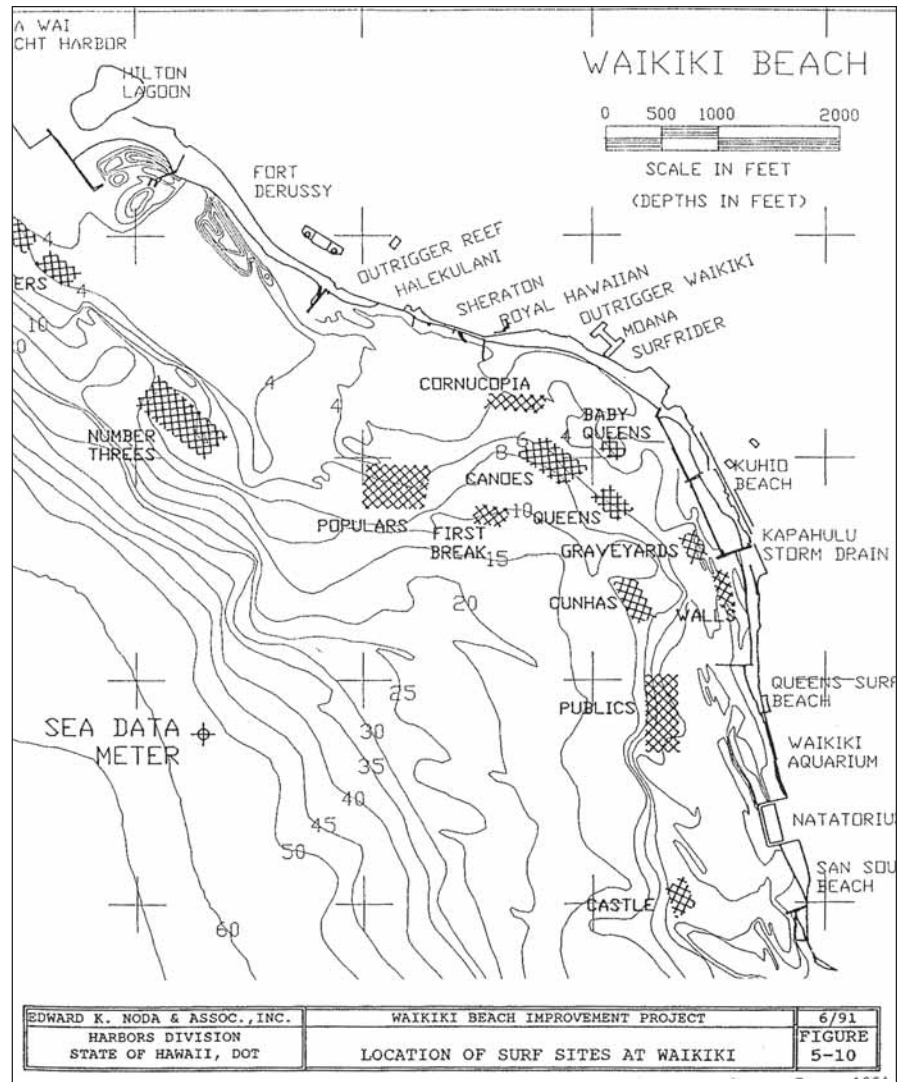
Figure 9. Locations of surf sites at Waikiki. (From Edward K. Noda & Associates Inc., July 1991.)

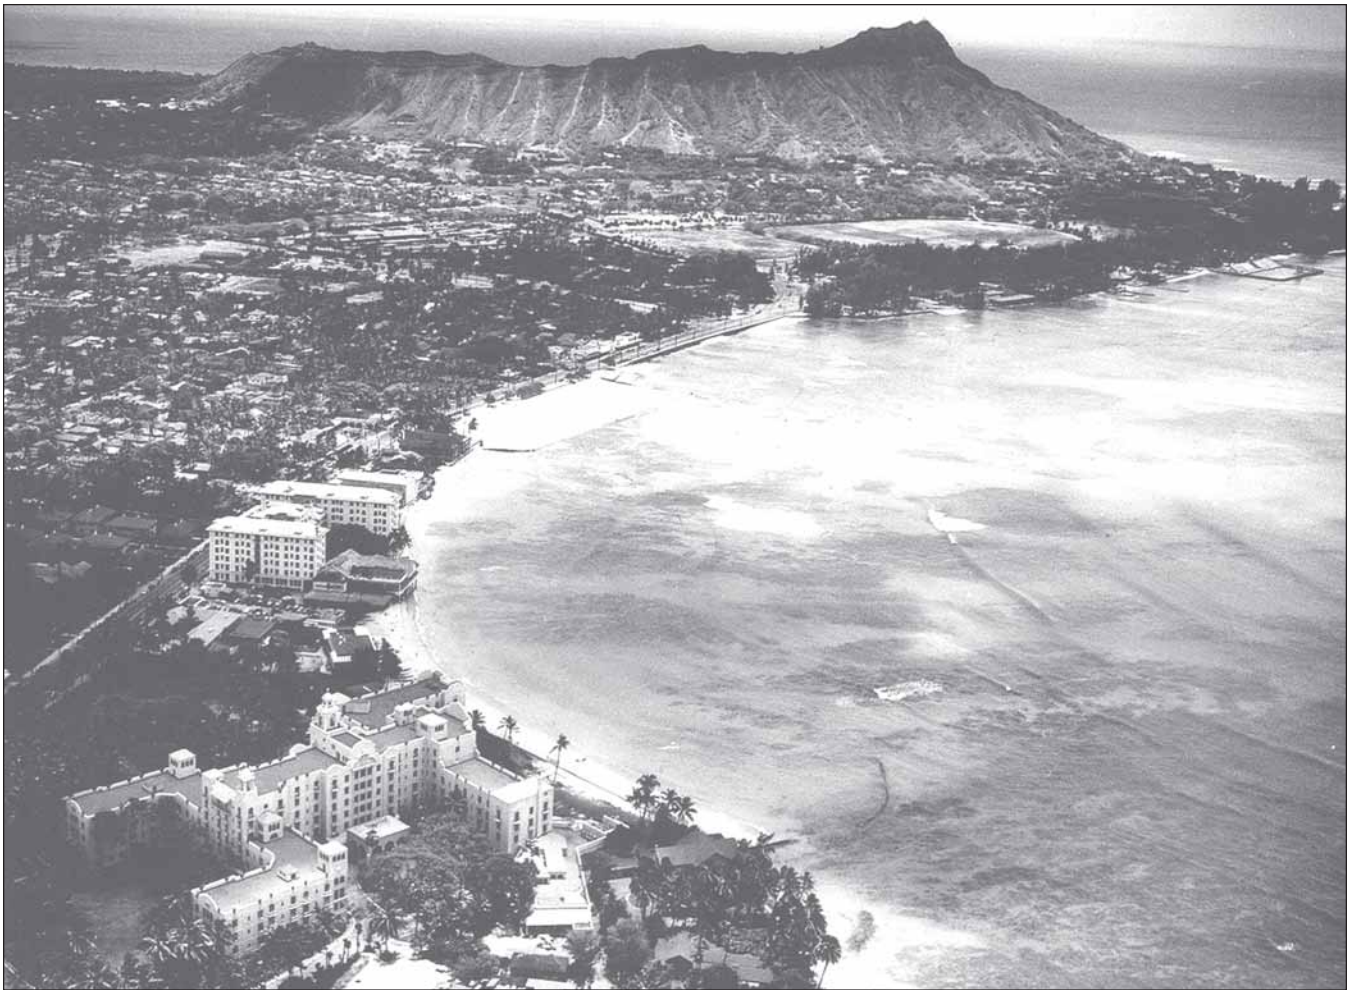
Figure 11. Aerial photo, circa 1940, looking toward Diamond Head; Royal Hawaiian-Moana Hotels Beach (curved groin near bottom); Kuhio Beach; “crib wall” breakwater; seawall along section of Kalakaua Ave.; Natatorium in distance at top right. (By Anon.)

Vegetation grows rapidly in this climate, and the bare sand beach was naturally narrow. The beach was encroached upon by people building homes, other structures, and landscaping, Figure 11. The postcard photo (circa 1910) shown

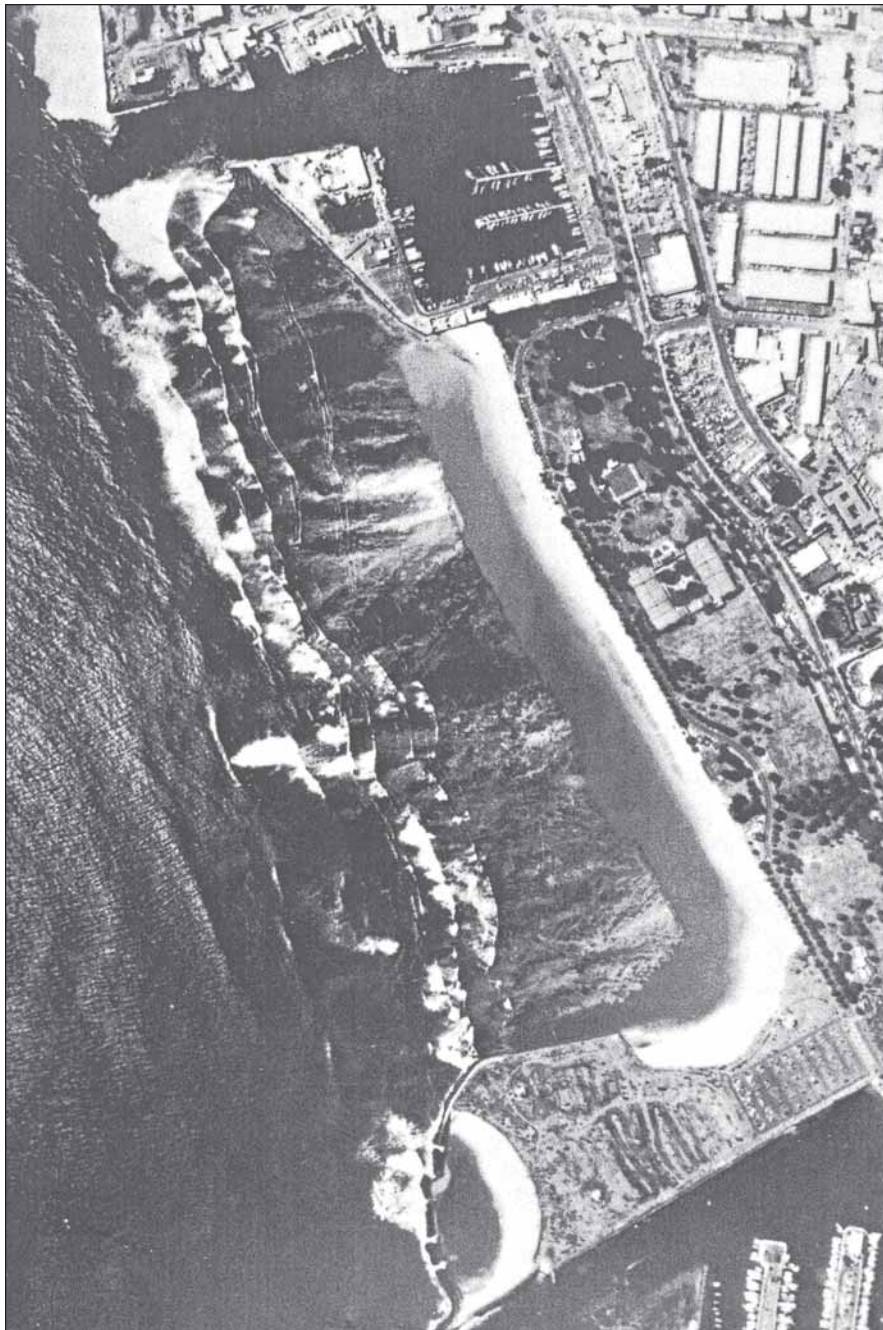
Figure 13. Ala Moana Reef, Kewalo Basin, Ala Moana Beach Park, Magic Island (Aina Moana), Ala Wai Yacht Harbor/Canal entrance; dredged channels, aerial photo. (From Gerritsen, March 1981, p. 215.)

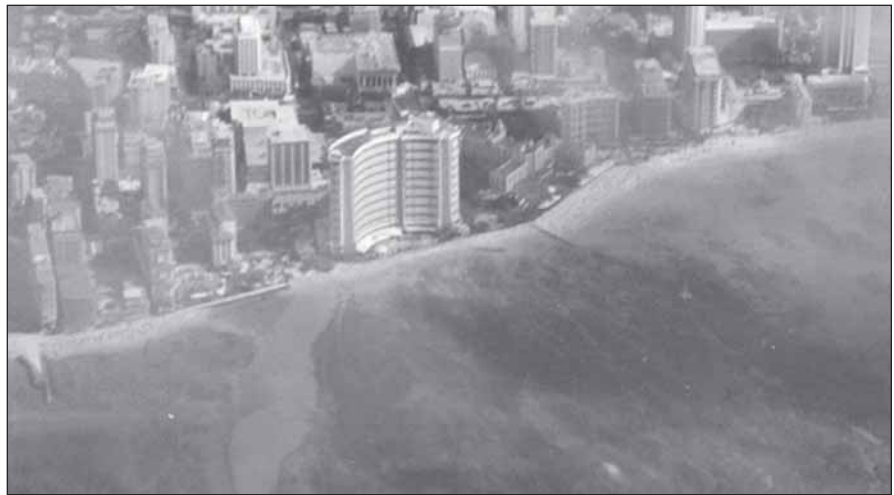
Figure 14. Halekulani, Sheraton Waikiki, Royal Hawaiian (and long curved groin), Moana Surfrider, Moana Hotels; Halekulani "sand channel" at left; aerial photo, cloudy, 30 January 1999. (By R.L. Wiegel, #9524.)

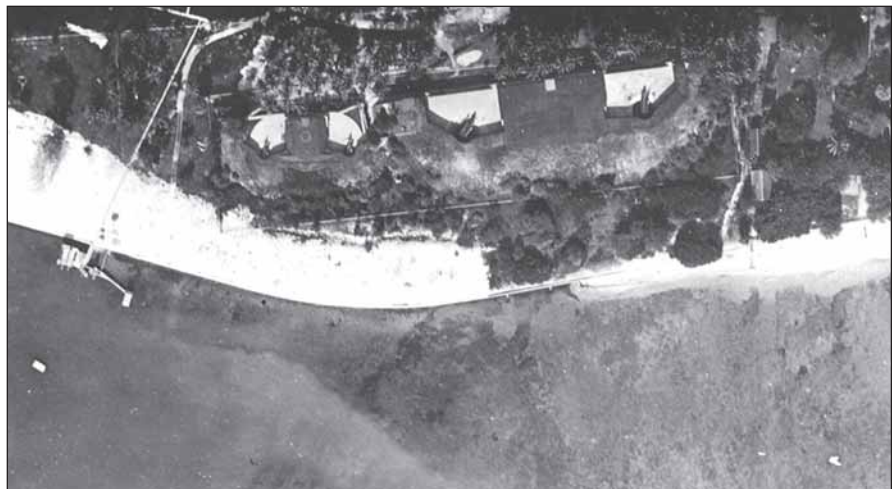
Figure 15. Vertical aerial photo of Fort DeRussy, 21 November 1919; narrow channel dredged in reef connecting to dredged channel in front of new beach. Note diving tower at left. (U.S. Army Museum of Hawaii, USAMH No. 2078.)

aerial photos of Figures 15 (1919) and 19 (1932). The channel had become a swimming basin.

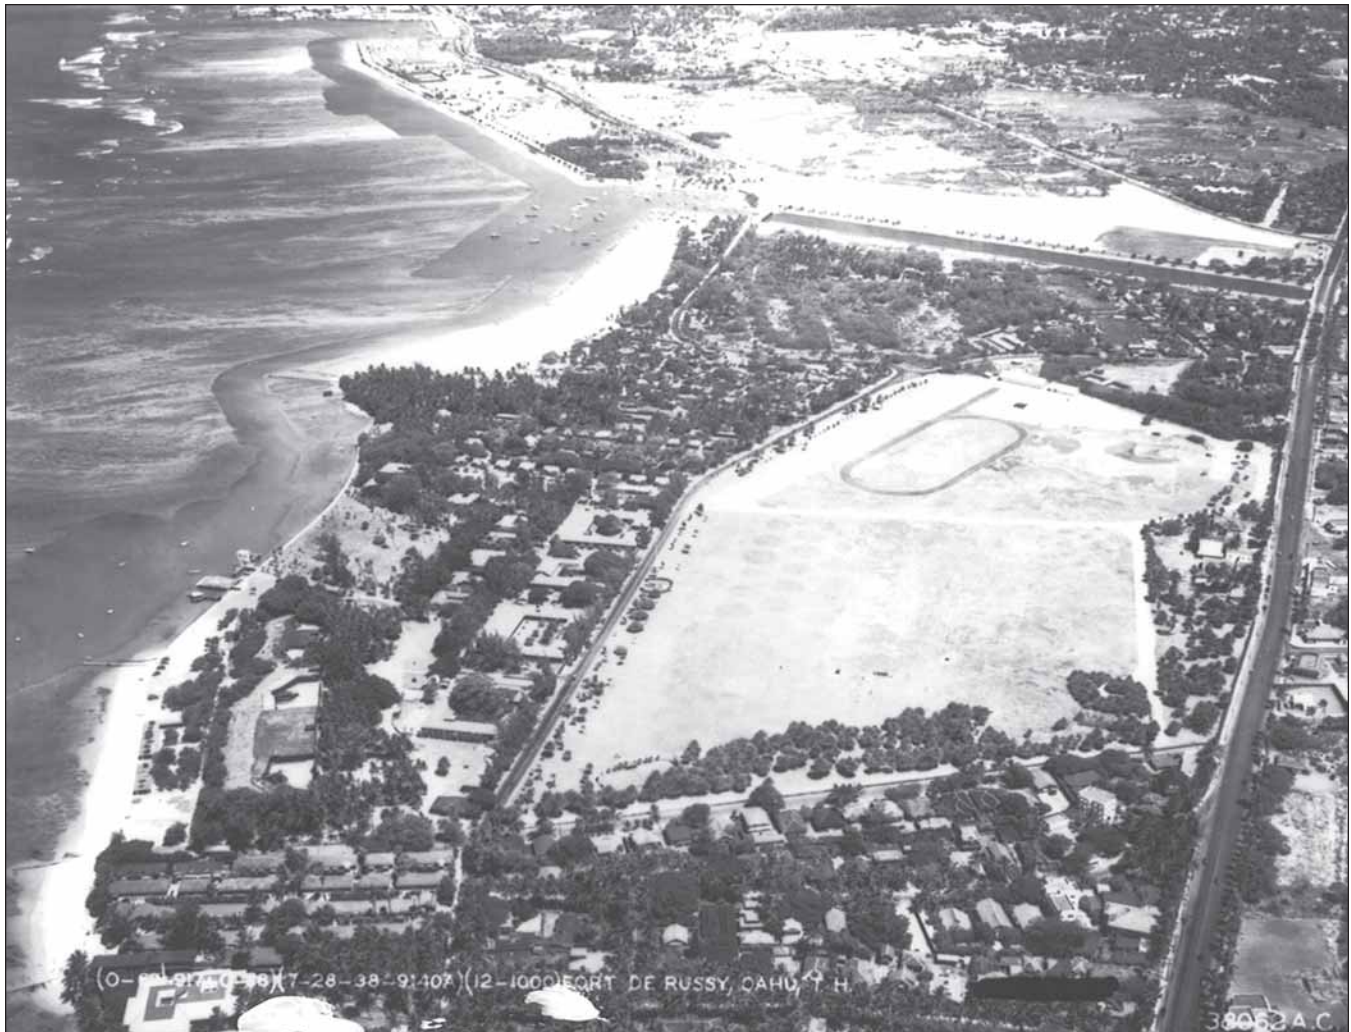
Figure 16. Oblique aerial photo of Fort DeRussy, Ala Wai Yacht Harbor, Ala Moana Beach Park, 28 July 1938, Dredged channels parallel to shore are evident. (U.S. Army Museum of Hawaii, USAMH No. 2789.)

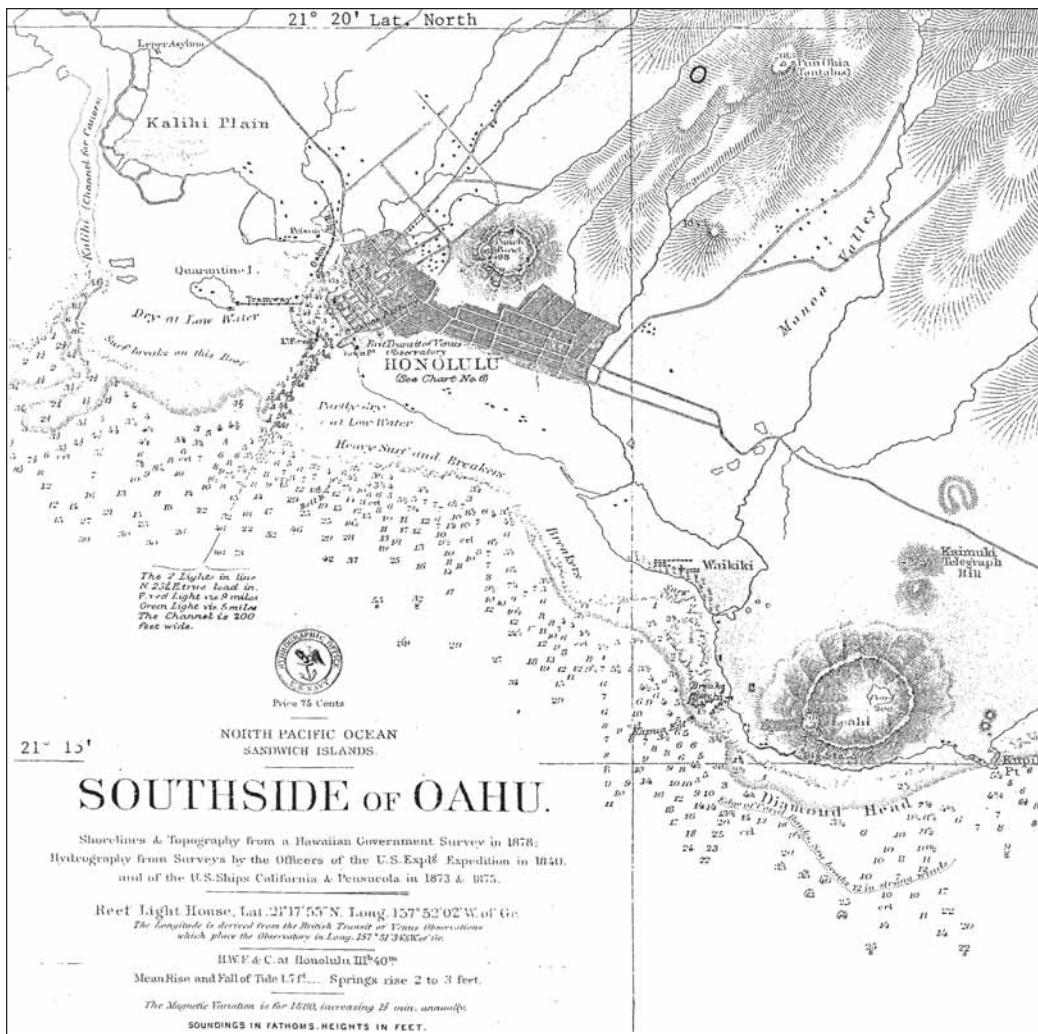
Figure 17. Southside of Oahu, Sandwich Islands, North Pacific Ocean, 1880. (U.S. Navy Hydrographic Office, No. 867; hydrography from survey in 1840, 1873 and 1875; courtesy Survey Division, State of Hawaii.)

Kapua Entrance is a natural channel through the reef that extends nearly to shore here. It is shown on the 1880 chart of the U.S. Navy Hydrographic Office, Figure 17. [Historic note. The first submarine communication cable between San Francisco and Honolulu was brought ashore through the Kapua Entrance (Channel) on 28 December 1902; Clark (1977) says remnants of the old submarine cable can still be found in this channel.] On 23 June 2002, Orville T. Magoon observed the bottom in this channel, using a face mask. He took underwater photos, and one of them showed two cables (2" to 3" in diameter) on the "dead" coral rubble or hard bottom, but the cables were buried at some places. Copies of several of his photos are in

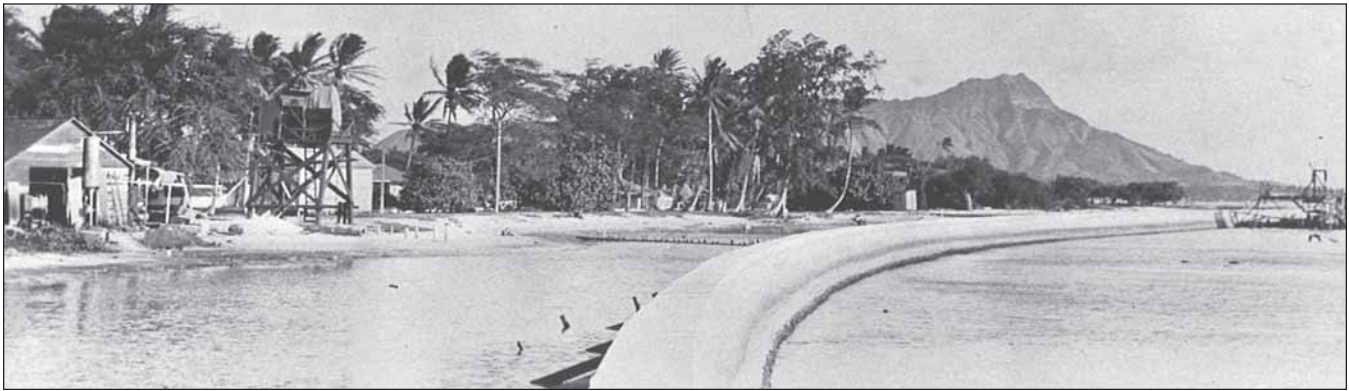
Figure 18. Looking along “new” seawall at Fort DeRussy, toward Diamond Head, circa 1916. Note seawater inland of seawall. (U.S. Army Museum of Hawaii, USAMH No. 4582.)

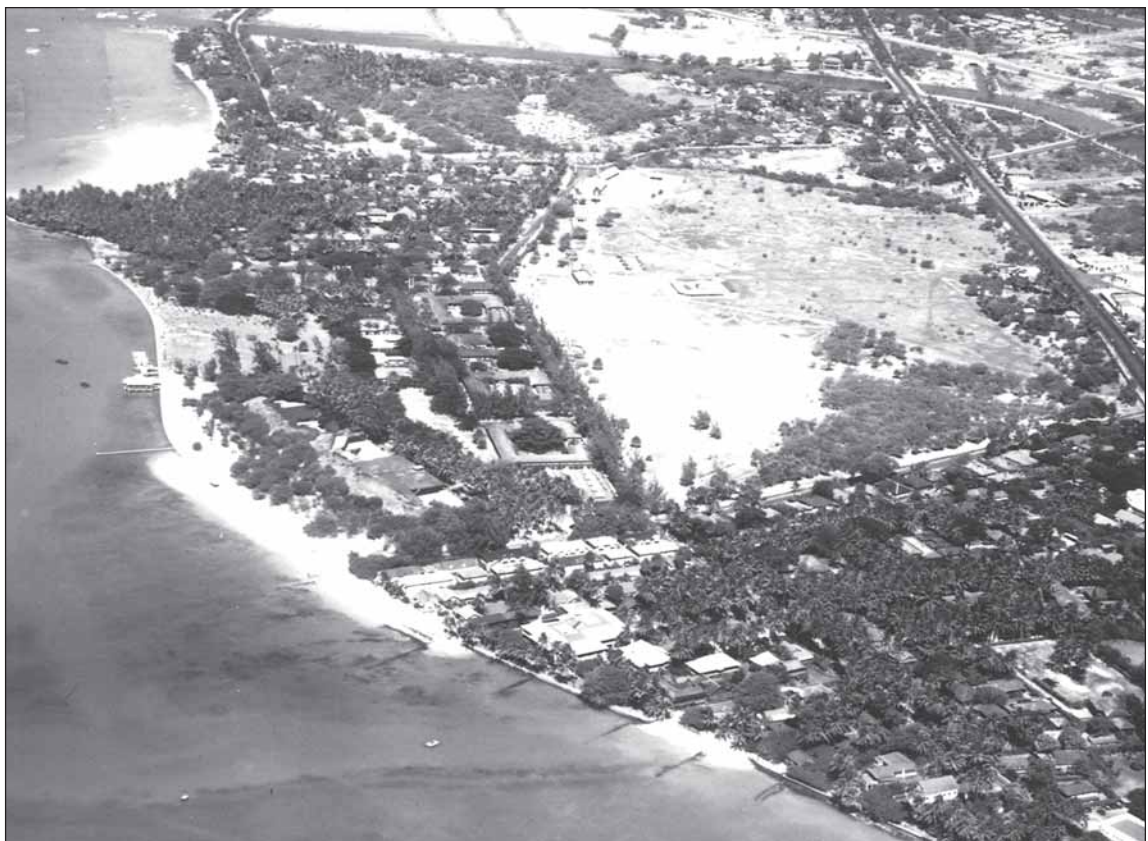
Figure 19. Oblique aerial photo, looking from west boundary of Royal Hawaiian Hotel to Fort DeRussy, Cassidy’s Point, and Ala Wai Canal entrance (at upper left), 2 November 1932. (U.S. Army Museum of Hawaii, USAMH No. 2788.)

Groins were built in this reach, which can be seen in the 1932 aerial photo, Figure 19. When Crane inspected them in 1972, all but one had completely deteriorated or were buried, or nothing remained. The short “YWCA groin” was in reasonable condition, owing to repairs; it is a short distance east of the Fort DeRussy storm drain/groin. A long box culvert/groin at the easterly end of Fort

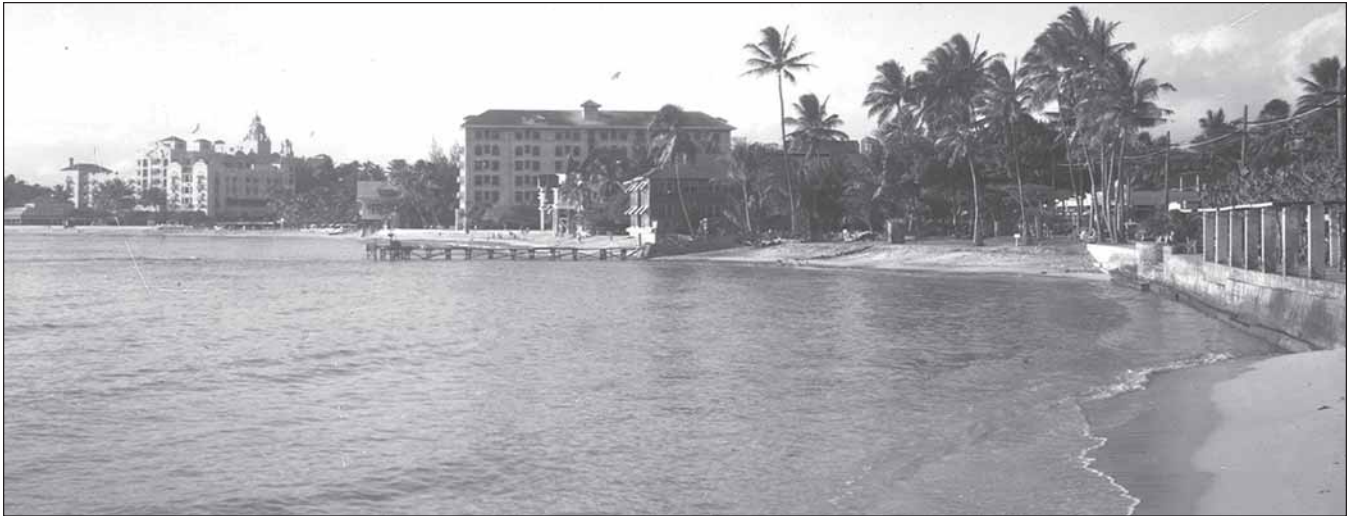
Figure 20a. Kuhio Beach, 20 May 1939, prior to construction of crib wall breakwater and placement of sand fill. (Courtesy USACE Beach Erosion Board.)

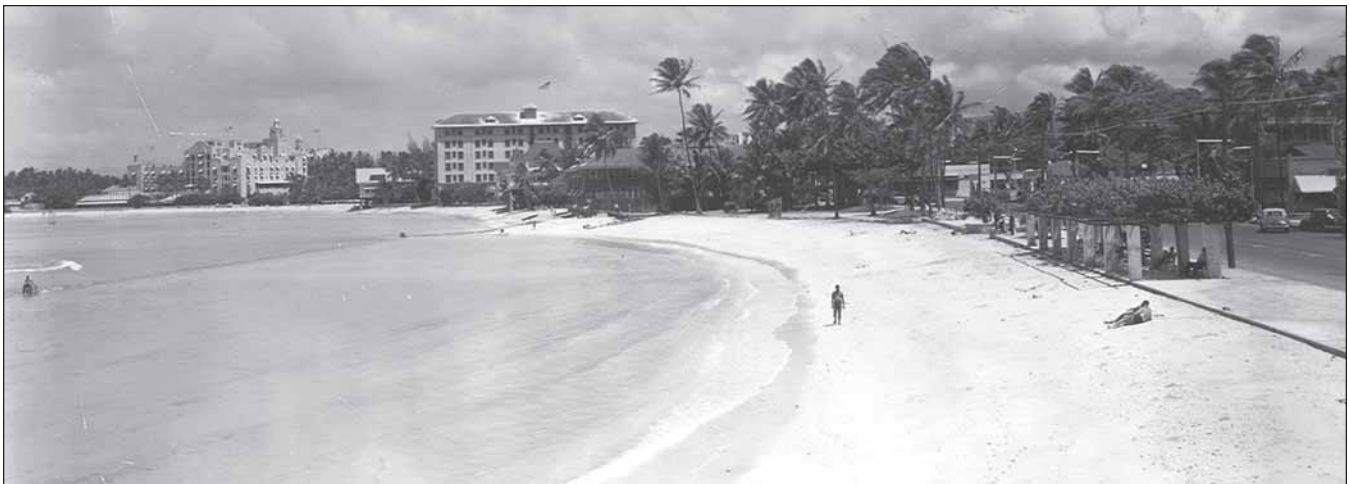
Figure 20b. Kuhio Beach, 1939, after construction of crib wall breakwater and placement of sand fill. (Courtesy USACE Beach Erosion Board.)

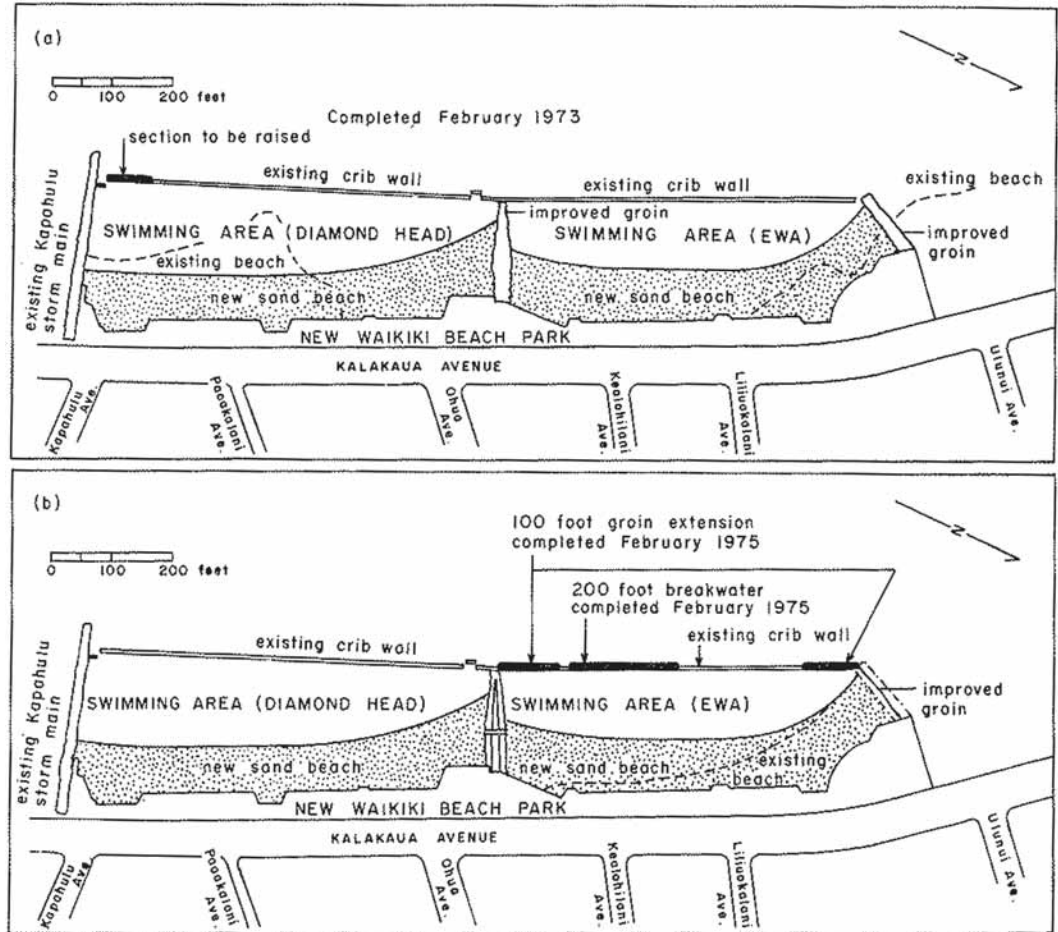
Figure 21 a,b. Kuhio Beach improvement plans: (a) 1973 and (b) 1975. (From Gerritsen, 1978, p. 29.)

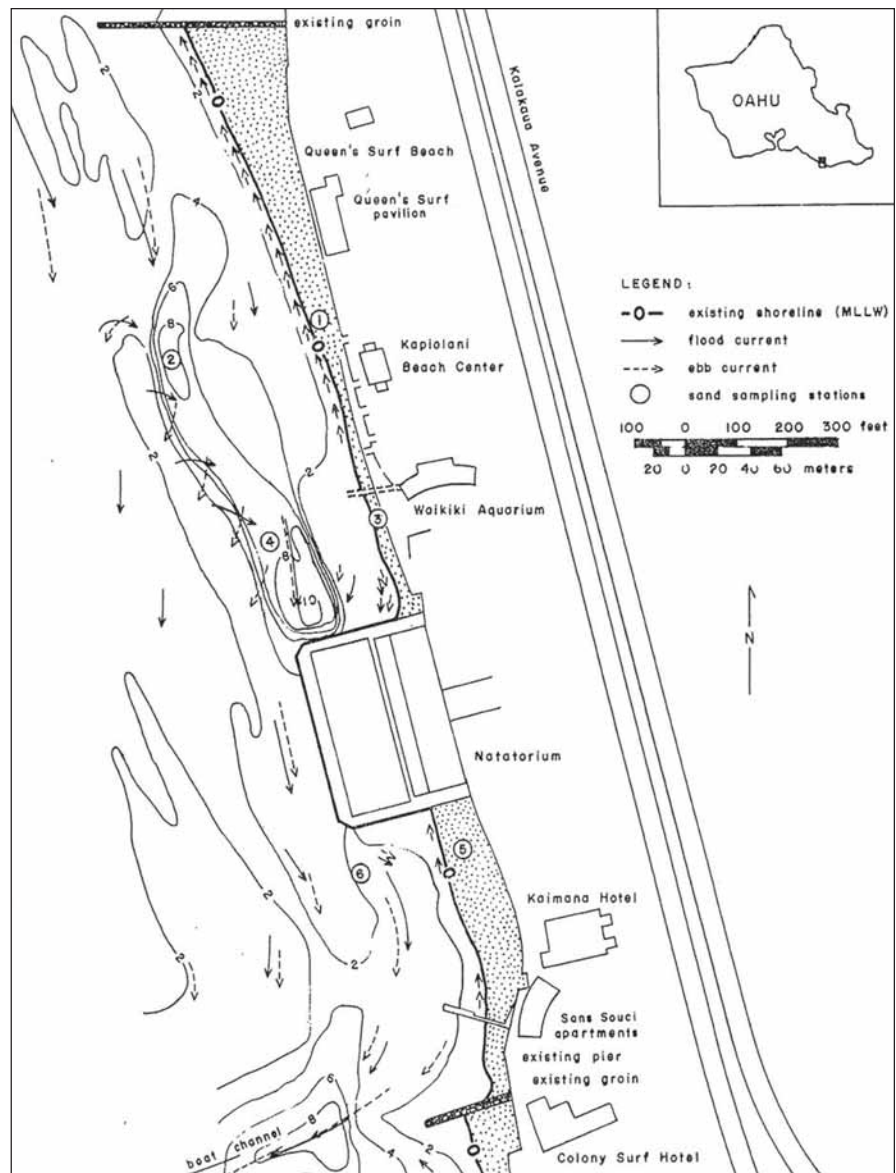
Figure 22. Ebb and flood current patterns around the Natatorium, and bathymetry; Queen’s Surf Beach/Kapiolani Park Beach, and Sans Souci (Kaimana) Beach. (From Gerritsen, 1978, p. 45.)

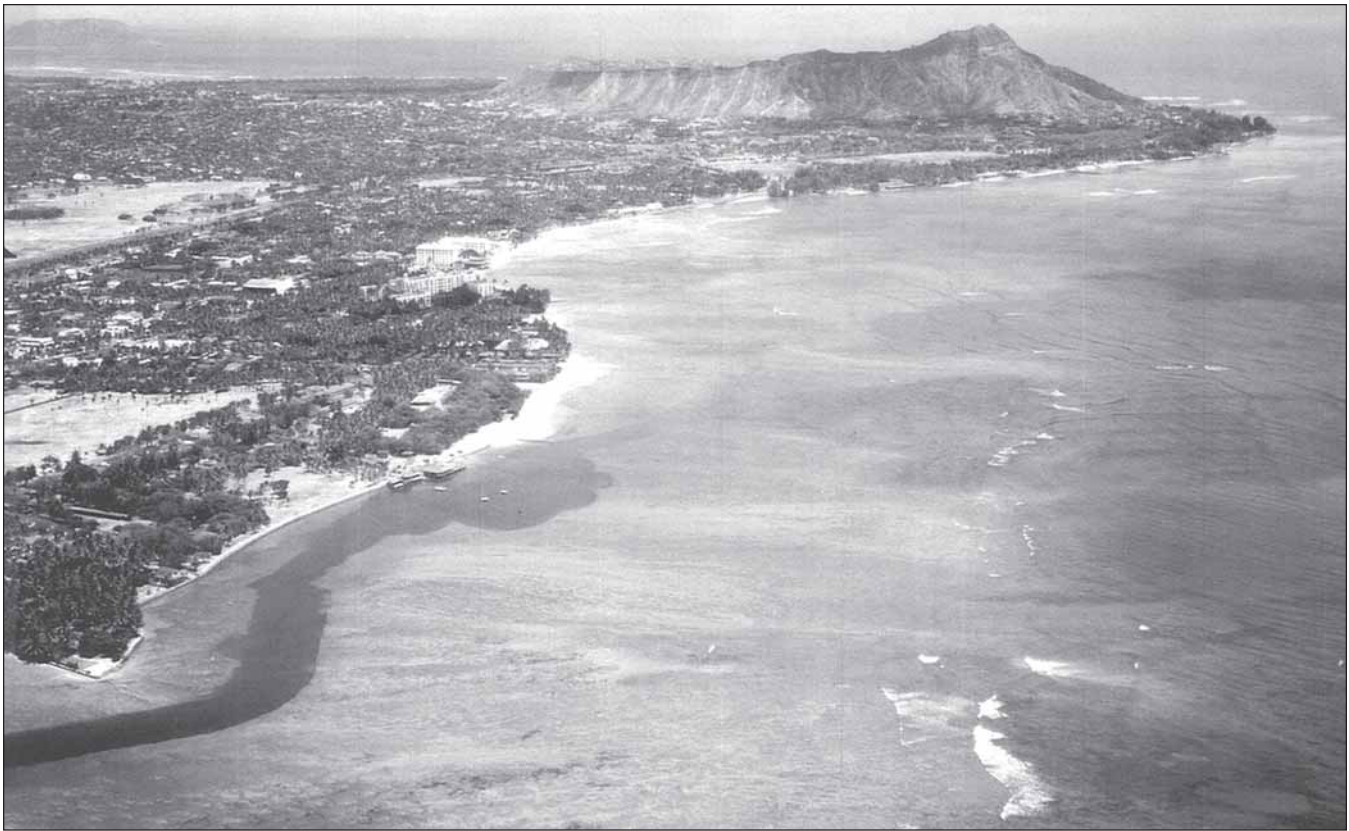
Figure 23. Aerial photo looking toward Diamond Head, 1946; Cassidy's Point, lower left and Fort DeRussy, 1946. Note dredged channel in front of Fort DeRussy. (From Isaacs, 1946.)

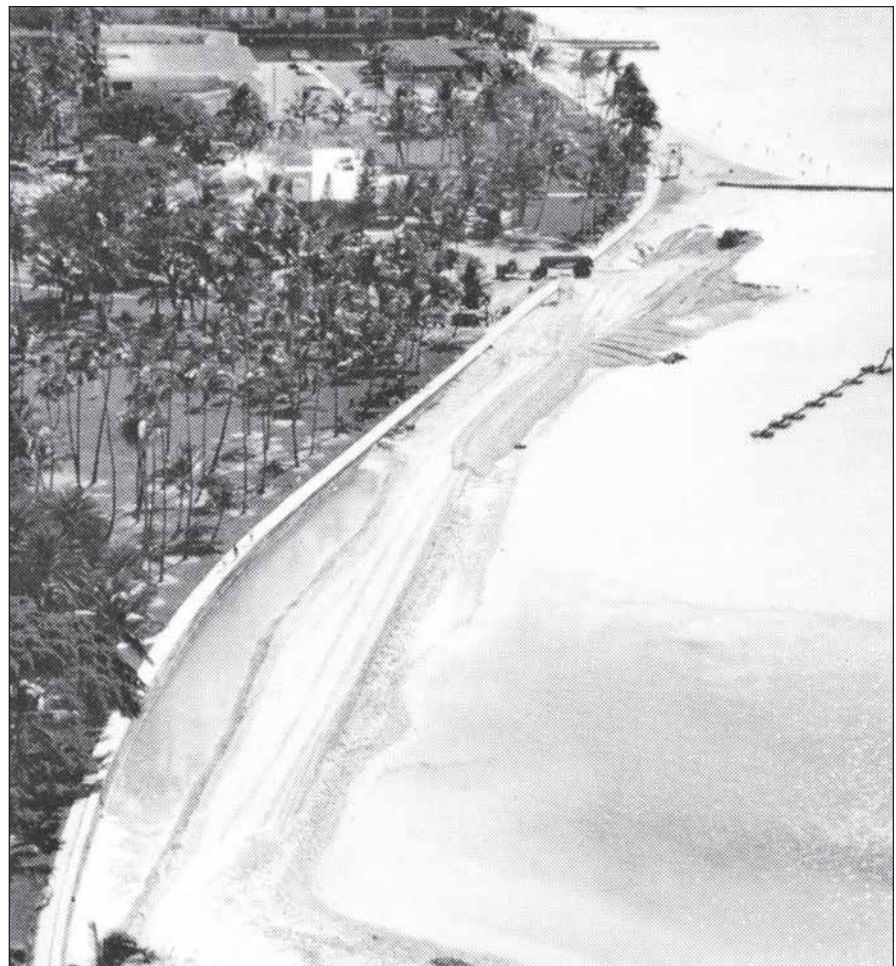
Figure 24. Fort DeRussy Beach; restoring sand beach, 1970 aerial photo; box culvert/groin near top (From Thompson, 1985, p. 259.)

The early work at Fort DeRussy has been described in a previous section. In 1957 "one severe storm caused the beach to virtually disappear" (USACE, Honolulu District 5 May 1975). A postcard of an aerial photo of Fort DeRussy, circa 1967 (Dexter Press), shows four groins with evidence of alongshore transport of sand towards "Diamond Head." According to Crane (1972) the groins were removed in 1970. In 1969 a beach construction project was authorized, which was done in 1970. This beach was built in front of the seawall. An aerial photo of the work underway is in Figure 24. The box culvert and groin, which was

built in 1917 at the easterly boundary, can be seen at the top center. The beach, about 1,800 feet long, was made with about 82,000 cubic yards of dredged coral material and concrete debris. Unwashed crushed coral sand was used to cover the fill (Thompson 1985). During construction Waikiki was subject to high winds and waves by a storm on 13-14 January 1970; but there was no damage to the beach or to construction equipment (Yoshimoto 1970).
